Docket No. 217 – Development and Management Plan Inspection

Northeast Utilities Service Company Certificate of Environmental Compatibility and Public Need for the construction of a 345-kV electric transmission line and reconstruction of an existing 115-kV electric transmission line between Connecticut Light and Power Company's Plumtree Substation in Bethel, through the towns of Redding, Weston, and Wilton, and to the Norwalk Substation in Norwalk, Connecticut.

Date: November 18, 2004

Location: Norwalk Substation Expansion

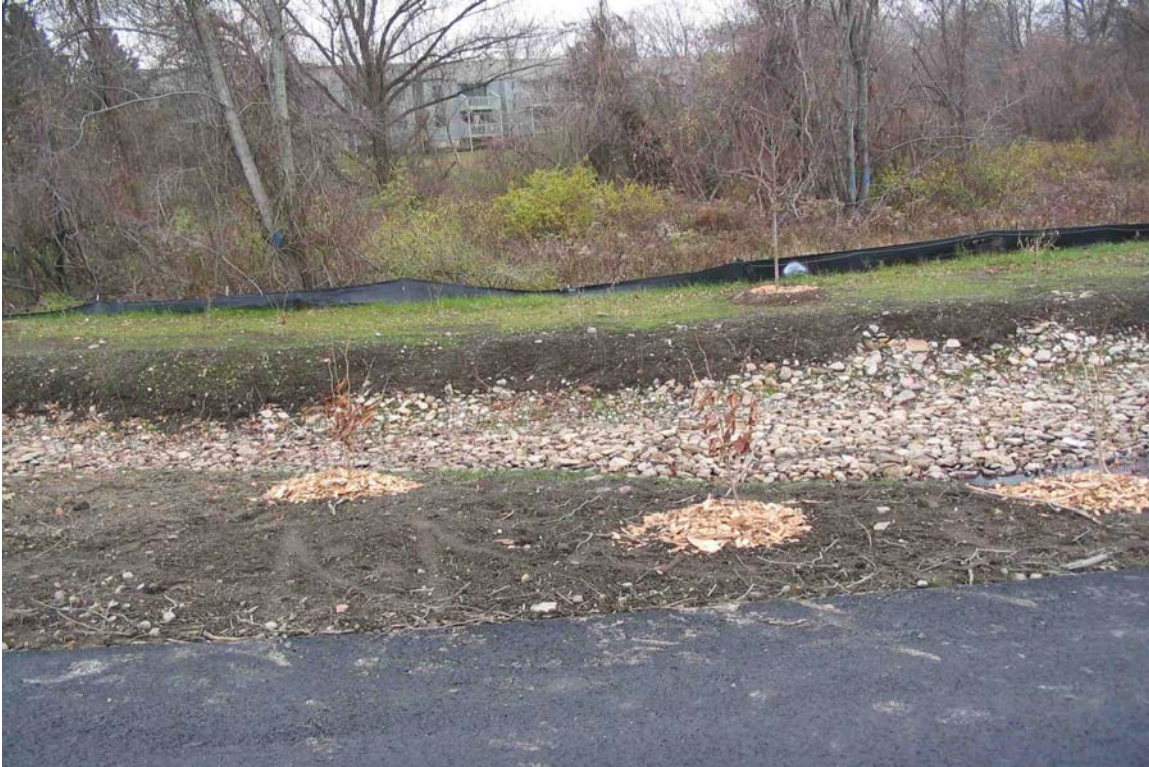
Slightly more grass growth was noticeable along the channel. The area was scheduled for hydroseeding the following day which should serve as a more effective stabilizer here. 11/18/04

- The areas around the recent landscaping and the overflow channel were scheduled to be hydroseeded the following day in an attempt to stabilize the area. This includes all the soil along the top and sides of the channel. 11/18/04.	- A small increase in grass growth was still observable at this inspection but the hydroseeding should be a good solution as a tackifier and mulch is included in the mix. 11/18/04

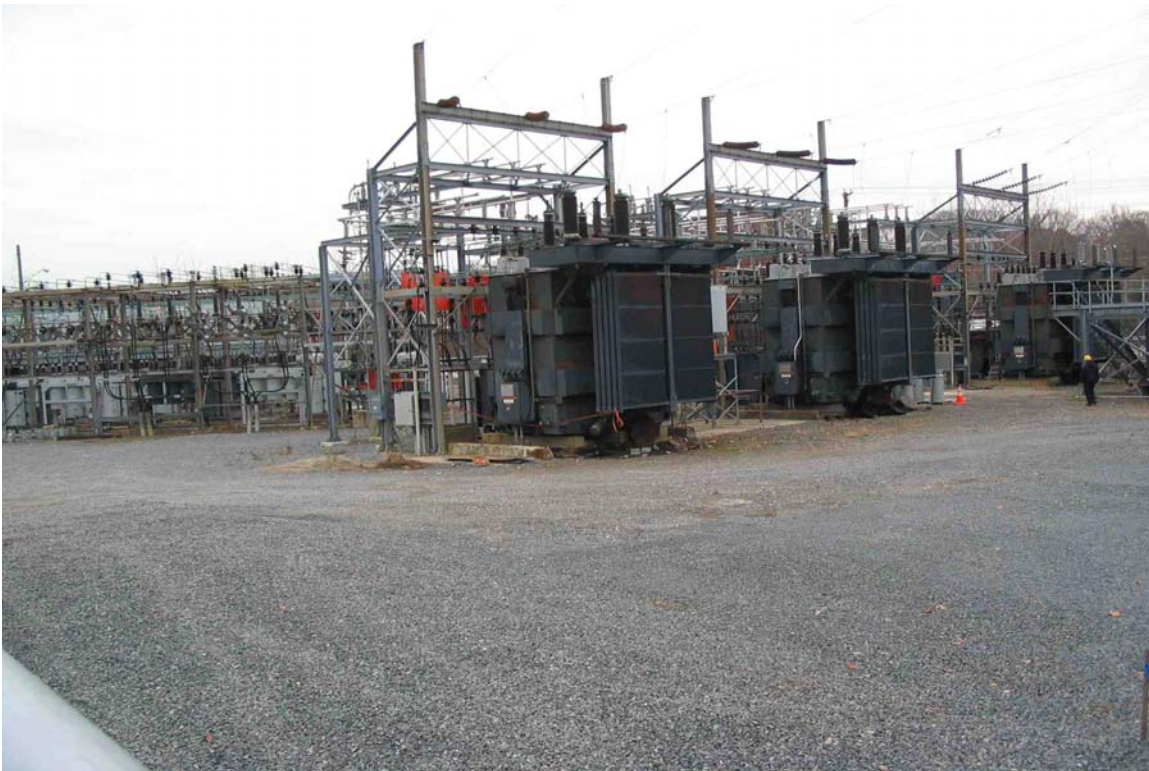
The excavation for the conduit within the yard has been completed and backfilled. 11/18/04

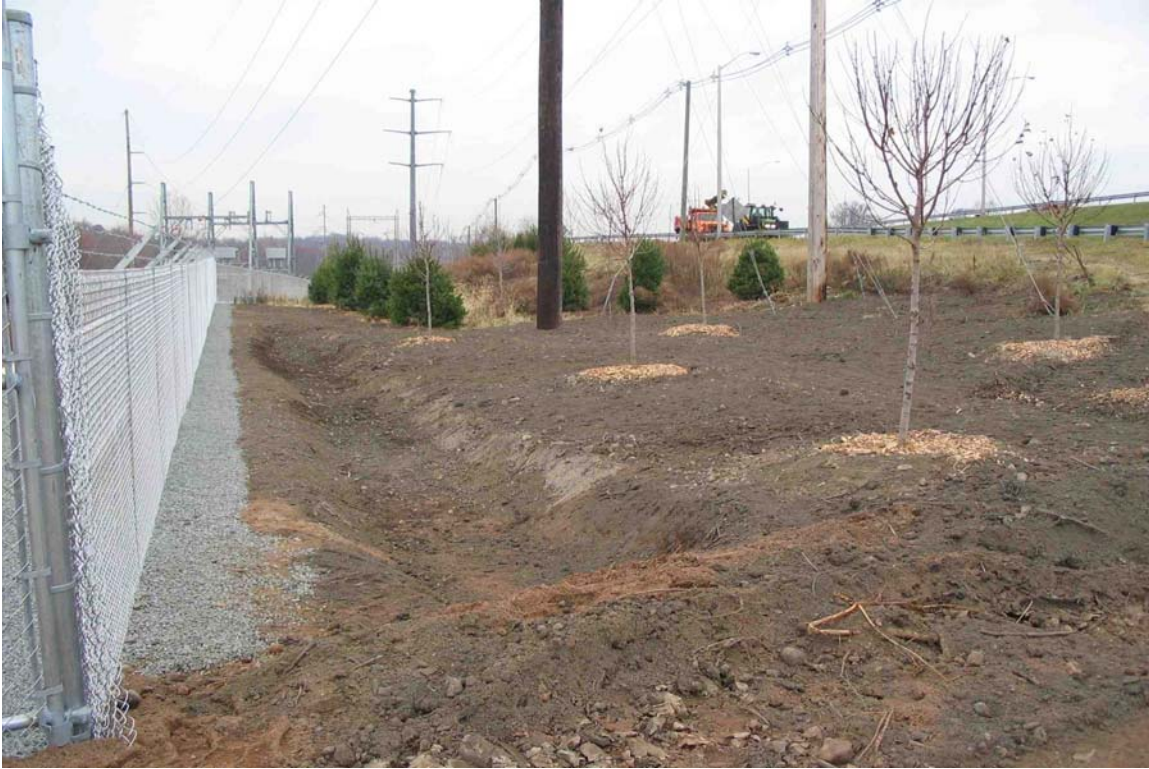
Plantings, topsoil and wood chips placed adjacent to the Route 7 ramp. The area was scheduled for hydroseeding the following day. 11/18/04

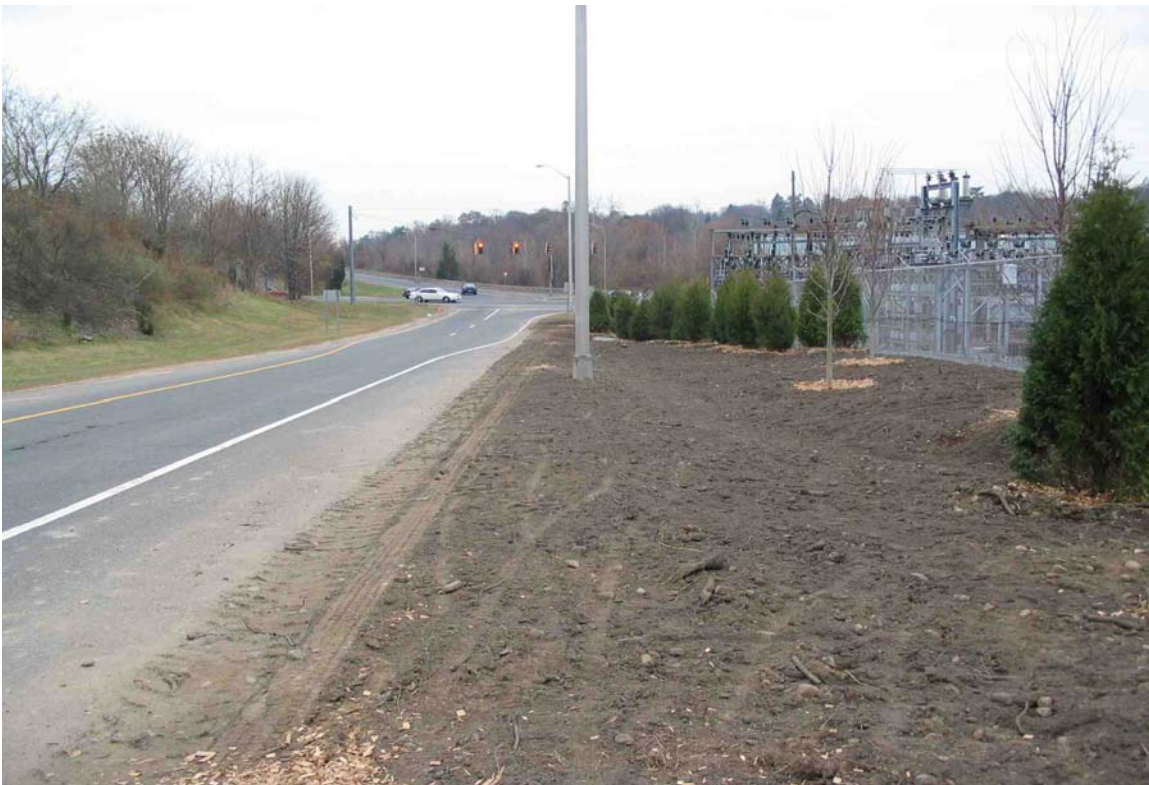
- Landscaping is completed along the perimeter fence at the ramp and New Canaan Ave. Some minor sediment tracking occurred to the shoulder of the ramp. 11/18/04	- Hydroseeding was scheduled for these areas the following day and this should serve as a stabilizer for these problems. 11/18/04

A view of the landscaping along the Route 7 ramp. Some minor sediment tracking had occurred on the shoulder of the roadway. Hydroseeding should provide a good stabilizer in this area. 11/18/04

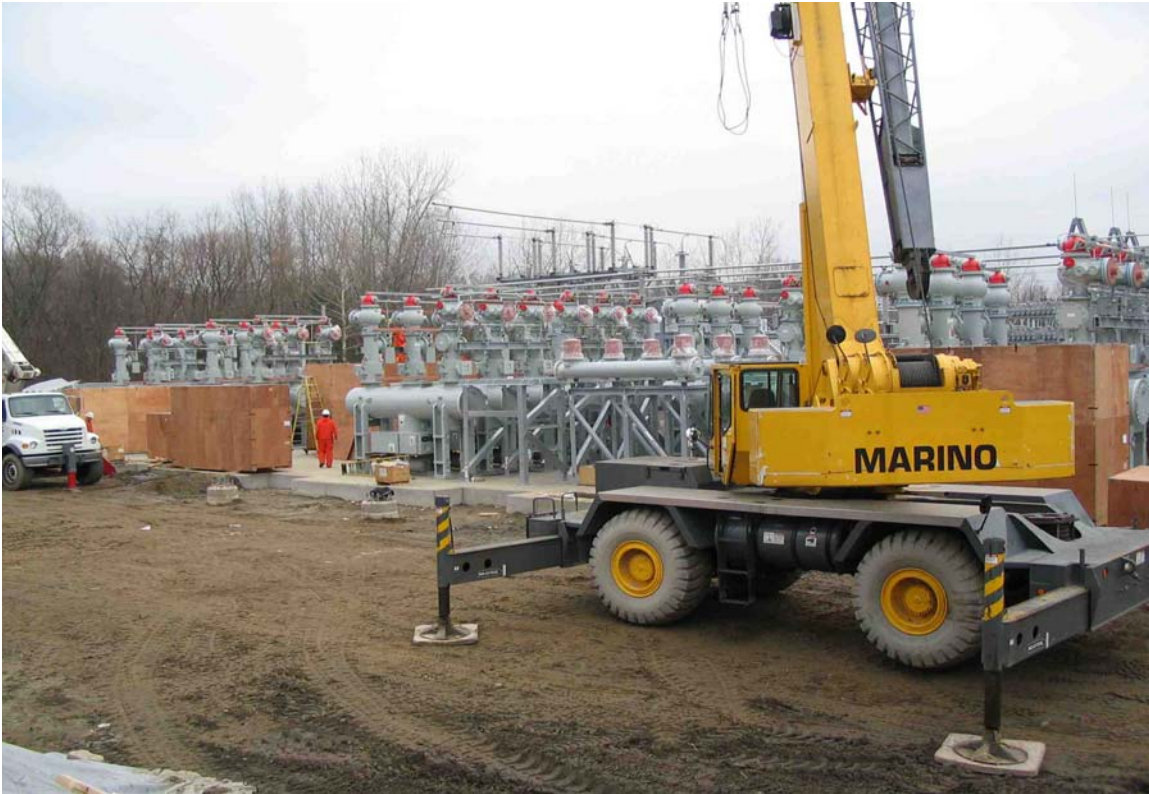
Plumtree Substation: View of the continuing placement of equipment on the concrete slab. 11/18/04

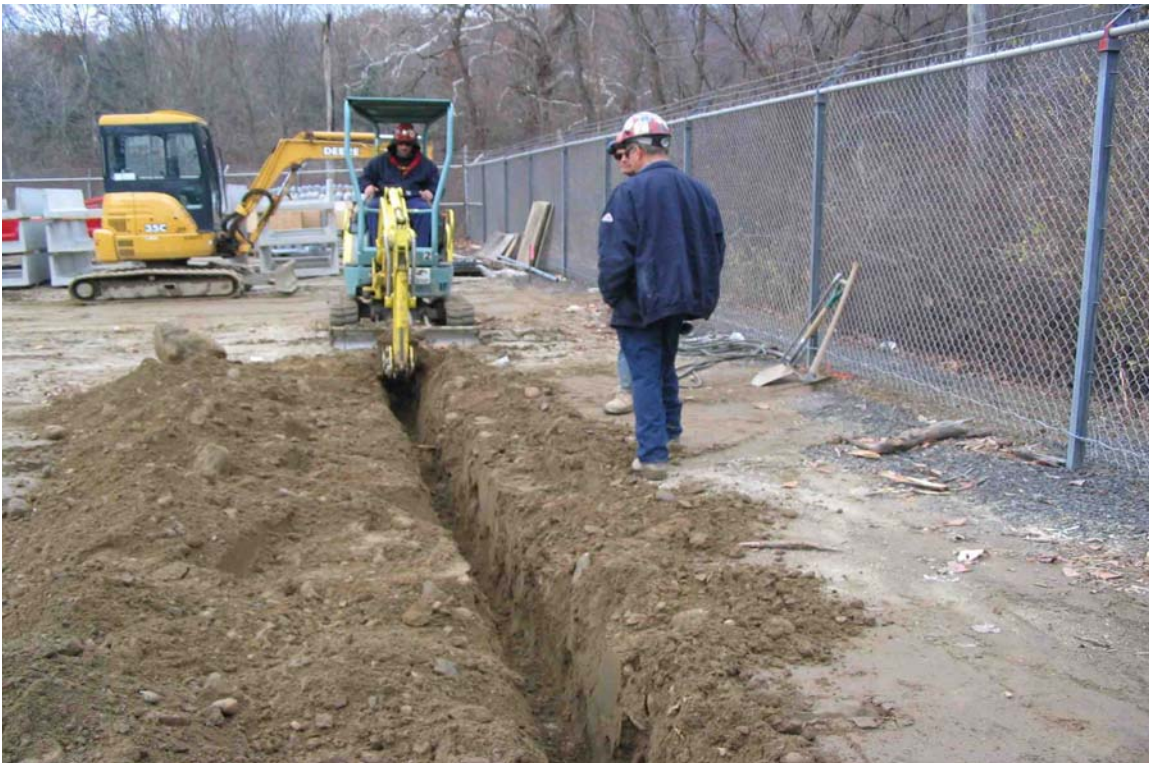
Minor excavation was occurring near the perimeter fence, but this trench will be opened and backfilled within the day. 11/18/04
